Manhole Inspection Summary

Manhole # S29K__016MH

Insp Date: **4/9/09 12:53 PM**

Location Address: **702 PORTLAND ST**

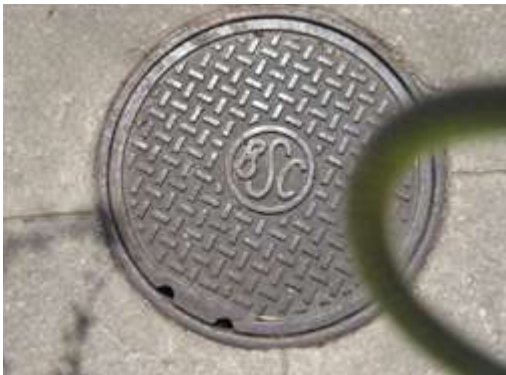
Miscellaneous

Cover pic

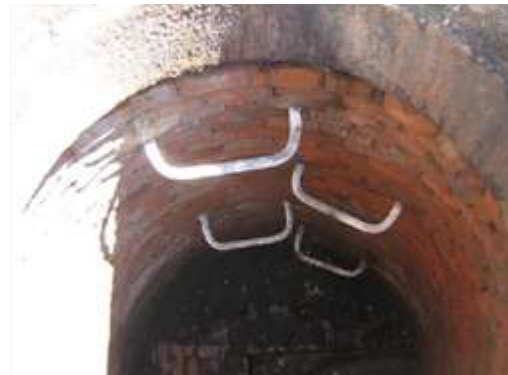
Miscellaneous

MH steps

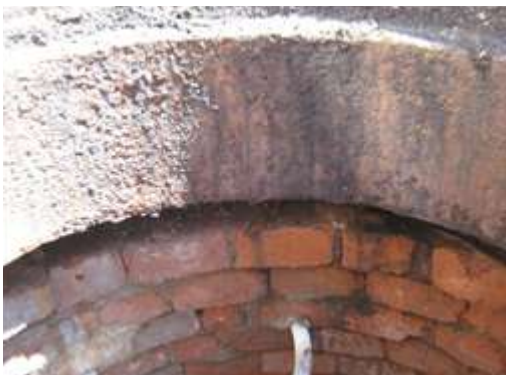
Defect 1

Frame Offset: **0** (in.) Condition: ☐ Sound ☐ Cracked ☒ **Leaks**

Infiltration: ☐ None ☒ **Joint** ☐ Cracks ☐ Mortar ☐ Roots ☐ Wall

lid/frame leaks; infiltration from chimney joint

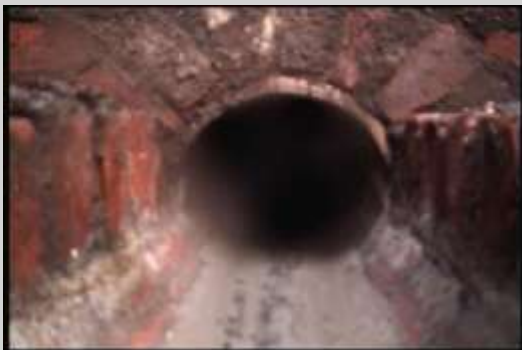
12 O'Clock Outflow

8 in. Circular Gravity Sewer
Pipe Out @ 12 O'Clock

Pipe Height: **8.4** (in.) Rod and Bar (Angled)
Pipe Material: **Clay** ☐ Pipe Lined
Invert Depth: **7.96** (ft.) Flow Characteristics: **Slow**
Deposits: ☒ None ☐ Mud ☐ Sludge ☐ Debris ☐ Grease
Silt Depth: **0** (in.) Deposits Extent:
Infiltration: **None** Pipe Seal Cond: **Sound**

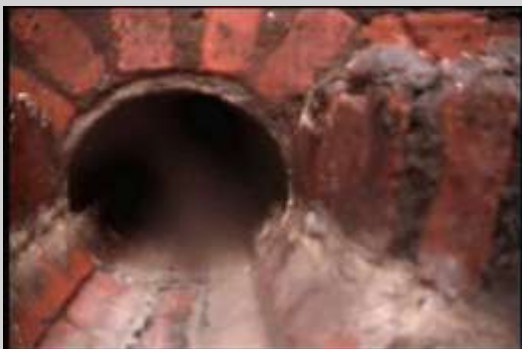
3 O'Clock Inflow

8 in. Circular Gravity Sewer
Pipe In @ 3 O'Clock

Pipe Height: **8.4** (in.) Rod and Bar (Angled)
Pipe Material: **Clay** ☐ Pipe Lined
Invert Depth: **7.94** (ft.) Flow Characteristics: **Slow**
Deposits: ☒ None ☐ Mud ☐ Sludge ☐ Debris ☐ Grease
Silt Depth: **0** (in.) Deposits Extent:
Infiltration: **None** Pipe Seal Cond: **Sound**
